# **INDOOR AIR QUALITY ASSESSMENT**

**Amesbury Fire Department  
17 School Street  
Amesbury, Massachusetts**

Prepared by:  
Massachusetts Department of Public Health  
Bureau of Environmental Health Assessment  
June, 2002

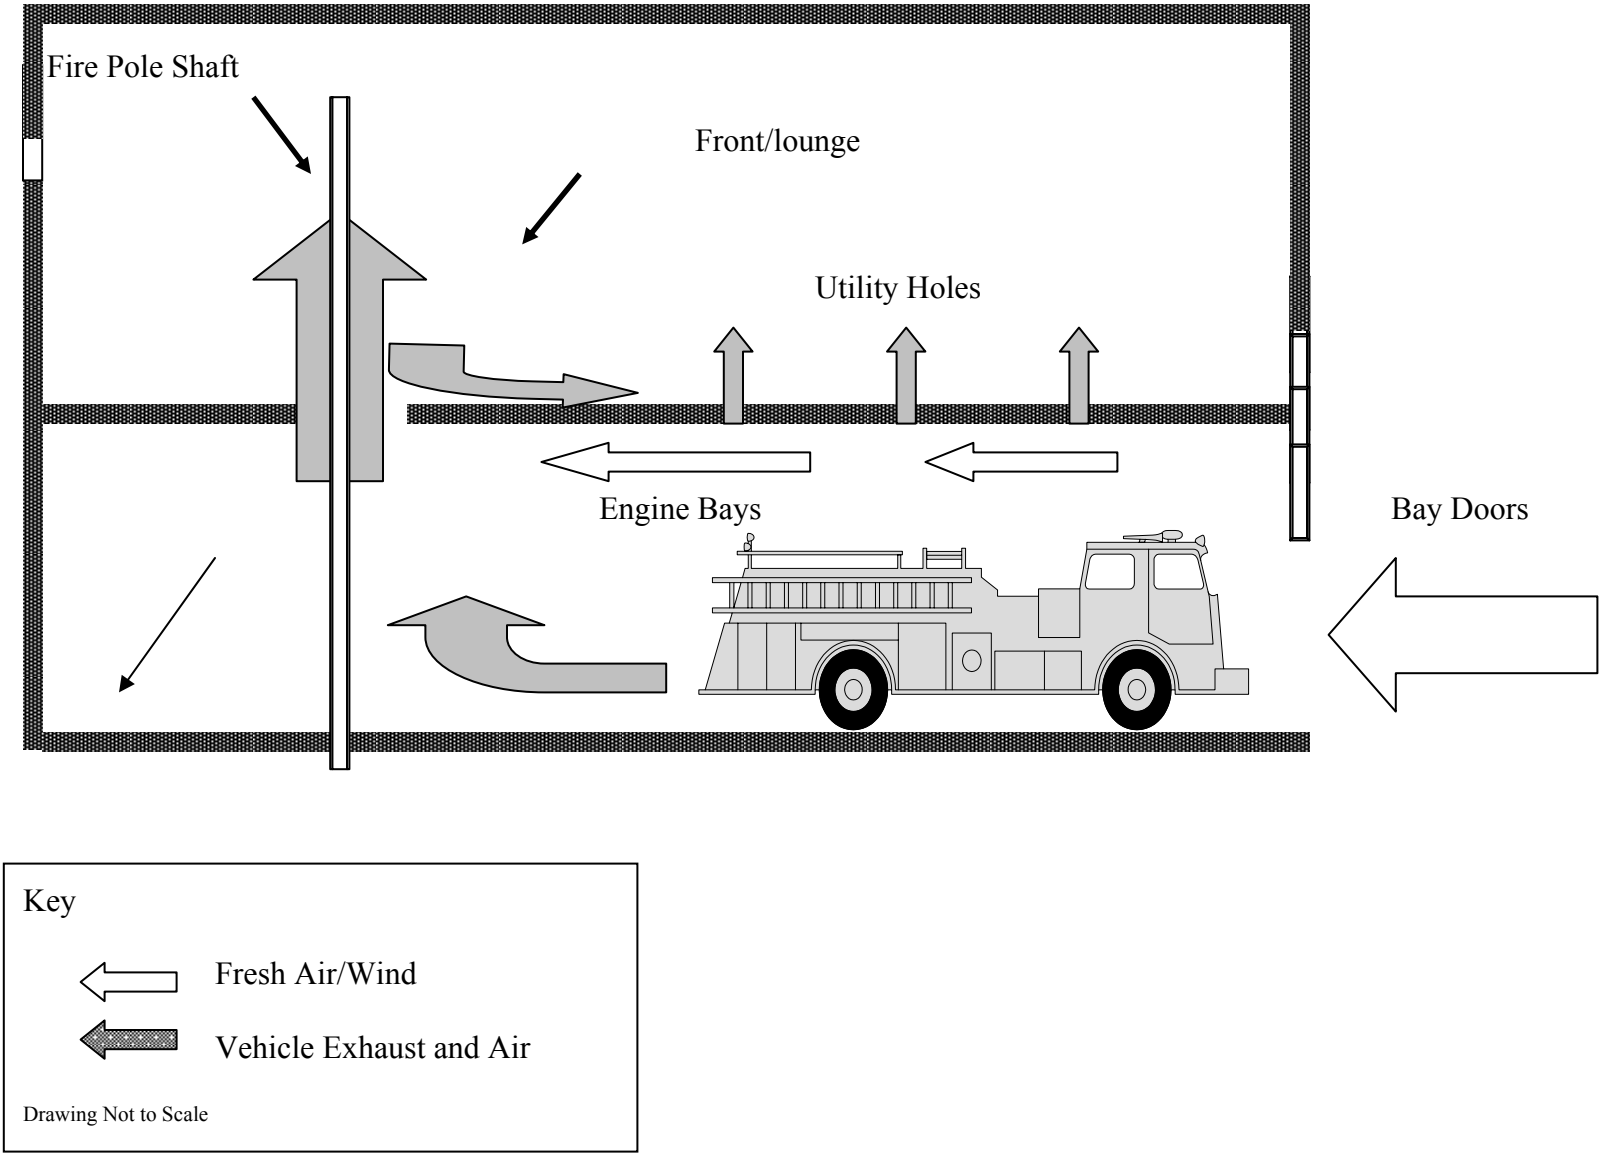
Figure 1

The station is not equipped with a mechanical exhaust system to remove exhaust from the engine bays during vehicle idling, which can allow vehicle exhaust emissions to accumulate within the station. A number of pathways for vehicle exhaust and other pollutants to move from the engine bays into occupied areas on both the first and second floors were identified (see Figure 1).

Potential Pathways of Air and Pollutant Movement from Engine Bays through Holes in Ceilings and Spaces around Door Frames

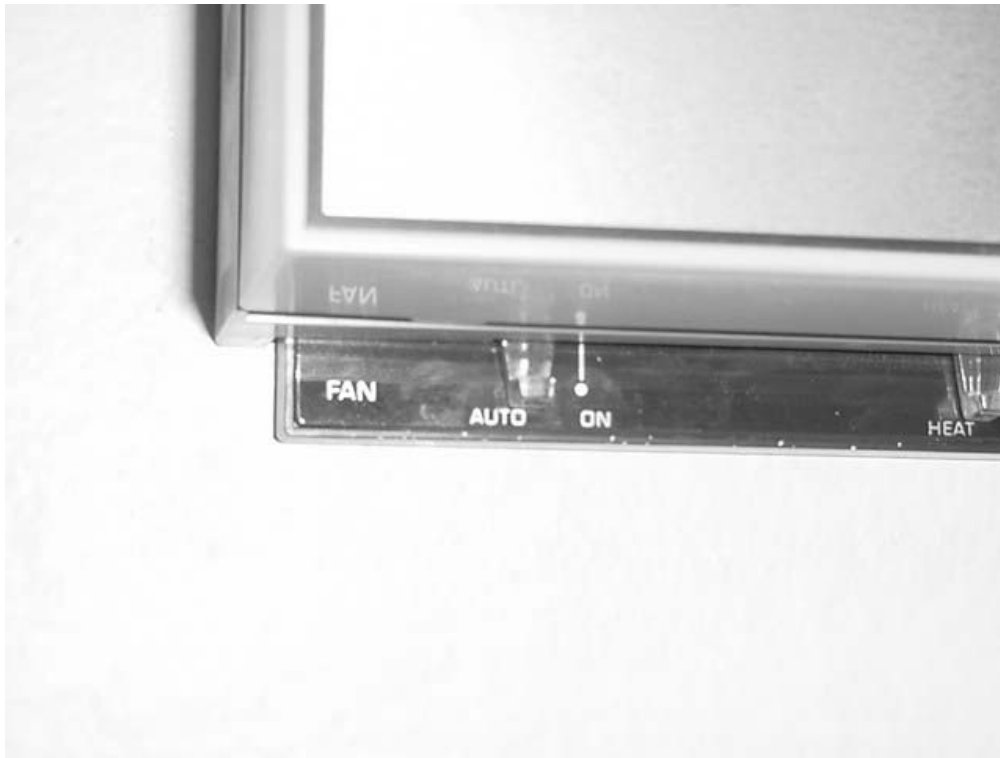
**Picture 1**

Wall-mounted thermostats control the HVAC system. The thermostats have fan settings of “on” and “auto” (see Picture 1). All thermostats were set to the “auto” setting during the assessment. The automatic setting on the thermostat activates the HVAC system at a preset temperature. Once the thermostat reaches a preset temperature, the HVAC system is deactivated until the temperature drops below the heating set point. Therefore, no mechanical ventilation is provided until the thermostat re-activates the system. No airflow from supply or return vents was detected during the assessment. Without dilution and removal by the HVAC system, pollutants can build-up in occupied spaces and lead to indoor air quality complaints.

**Wall-Mounted Thermostat - Note Fan Switch Set to "Auto"**

8. To maximize air exchange, the BEHA recommends that both supply and exhaust ventilation operate continuously during periods of building occupancy independent of thermostat control (excluding engine bay exhaust system). Consider setting

thermostat controls to the fan's "on" position to provide constant supply and exhaust ventilation.

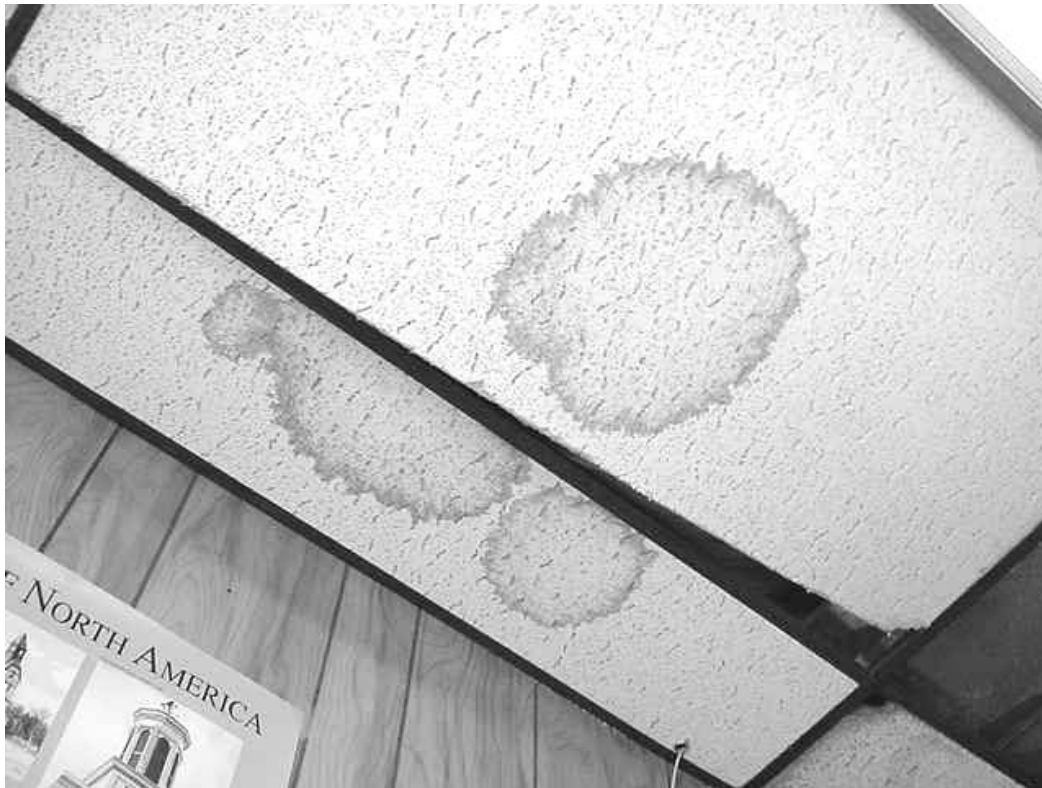
**Picture 2**

The building has reportedly experienced problems with water penetration, most notably the second floor ceiling (see Pictures 2 & 3). No obvious sources of interior moisture problems were noted. A number of conditions were observed which could potentially provide a means of water penetration into the building. Sections of the roof edge had no gutters or downspouts (see Pictures 4 & 5). Lack of proper roof drainage allows rainwater to run down the side of the building and pool on the ground at the base of the building against exterior

**Water-Damaged Ceiling Tiles**

14. Repair/replace damaged vent pipe on roof; have the plumbing system inspected by a licensed plumbing firm to ensure proper function.
15. Replace water-damaged ceiling tiles.

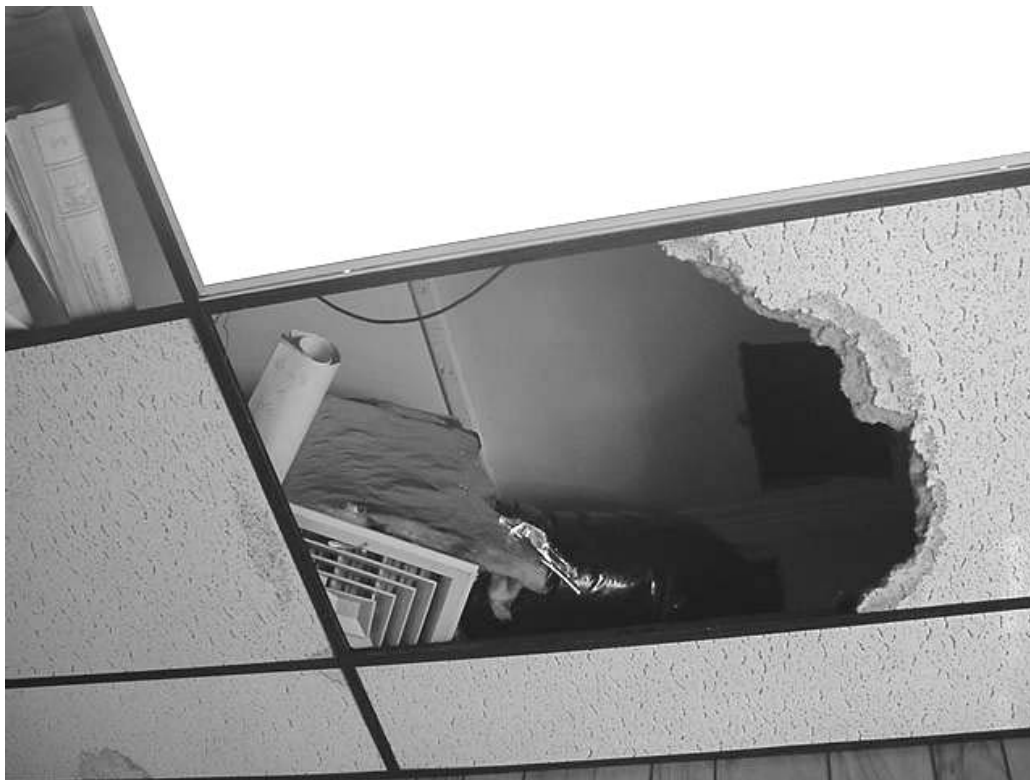
**Picture 3**

**Water-Damaged Ceiling Tiles**

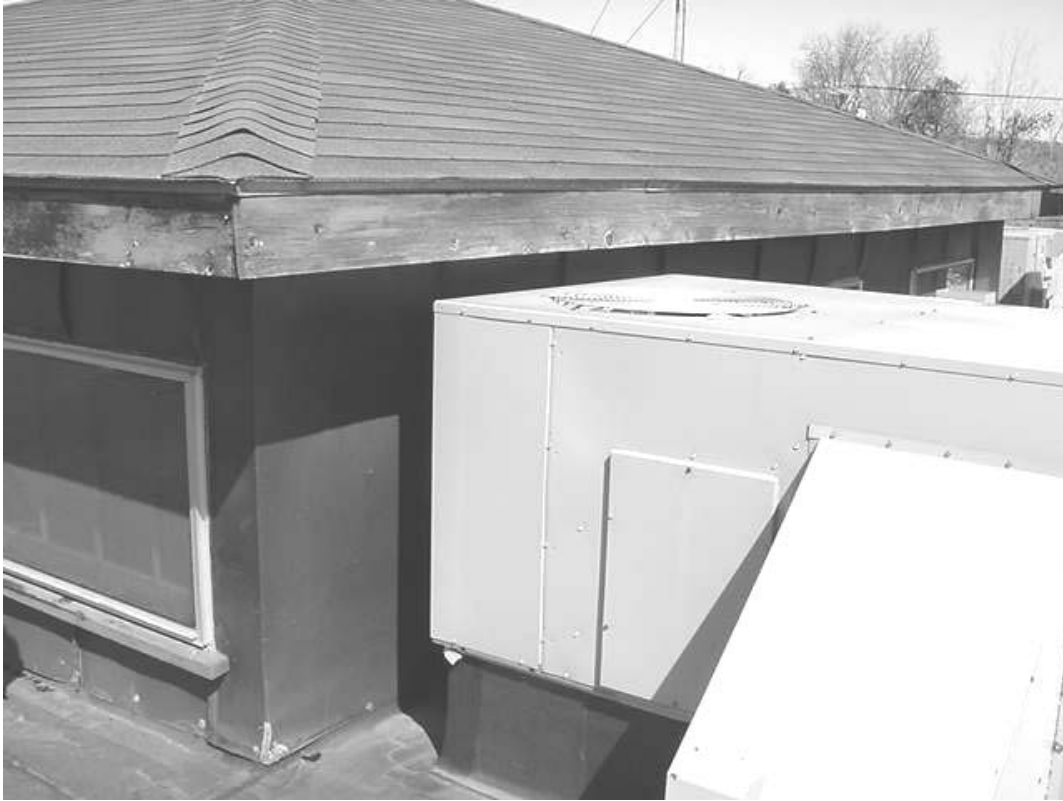
**Picture 4**

**Peaked Roof with no Gutters/Downspouts, Note Roof Drains Directly onto AHU**

11. Examine the feasibility of installing a gutter/downspout system to portions of the building where they are currently lacking (e.g., the peaked roof and communications).

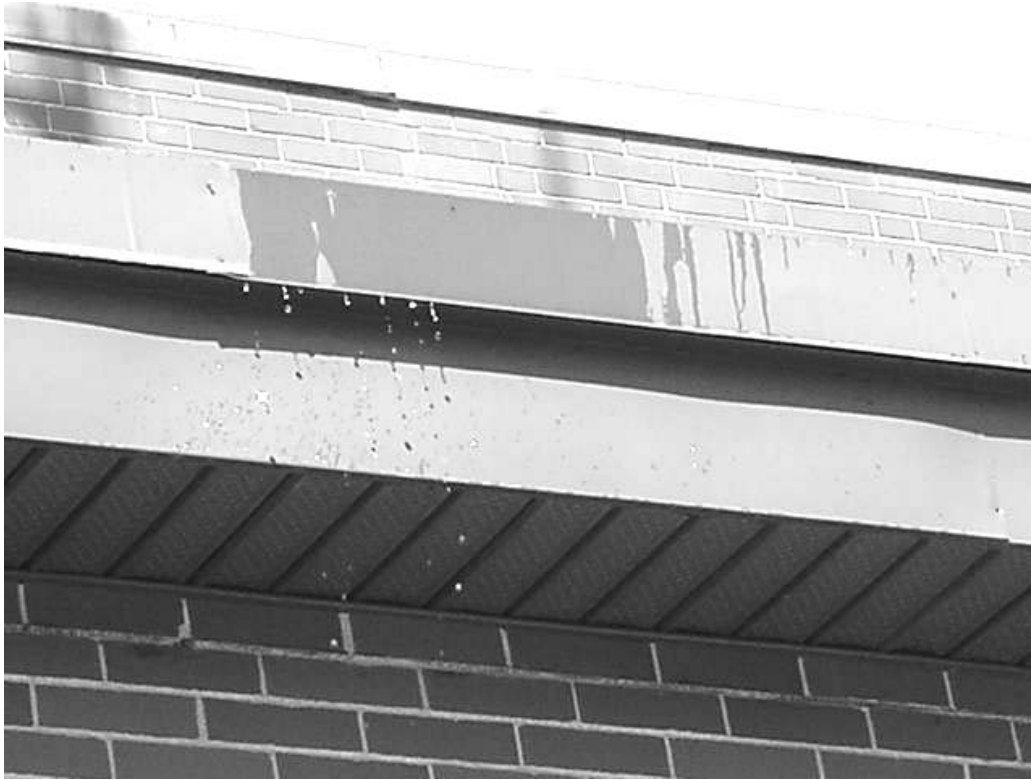
**Picture 5**

**Water Runoff from Communications Portion of Building**

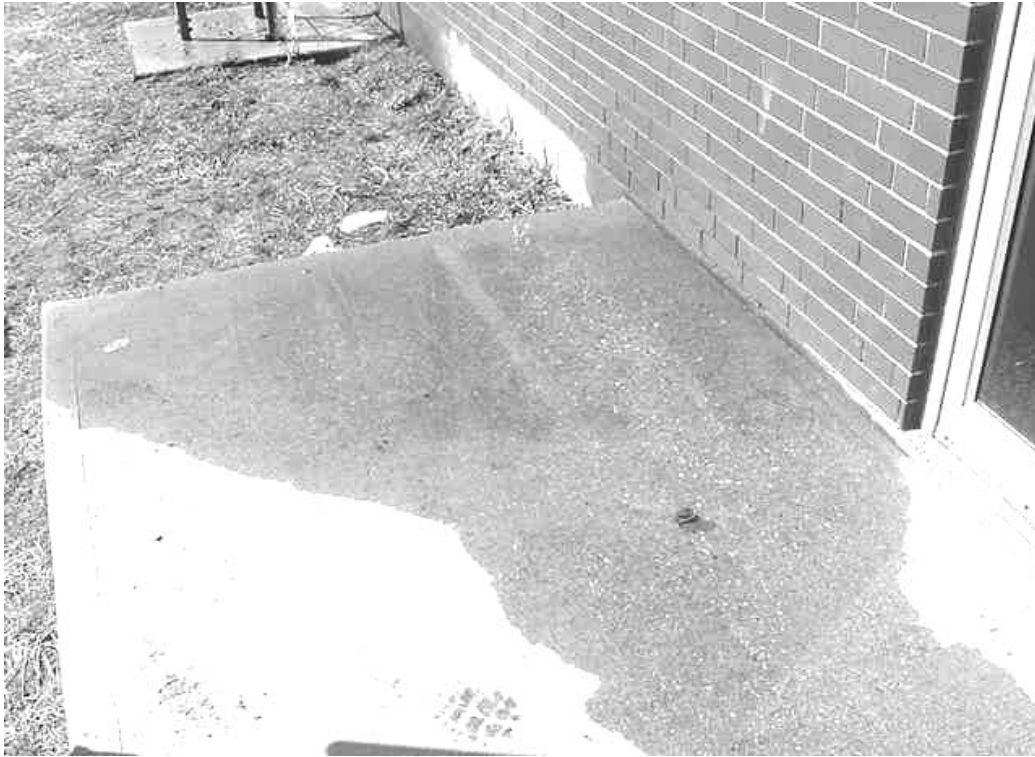
**Picture 6**

walls (see Picture 6). The freezing and thawing action of water during winter months can create cracks and fissures in the foundation. Over time, this process can undermine the integrity of the building envelope and provide a means of water entry into the building.

**Pooling Water against the Communications Exterior Wall**

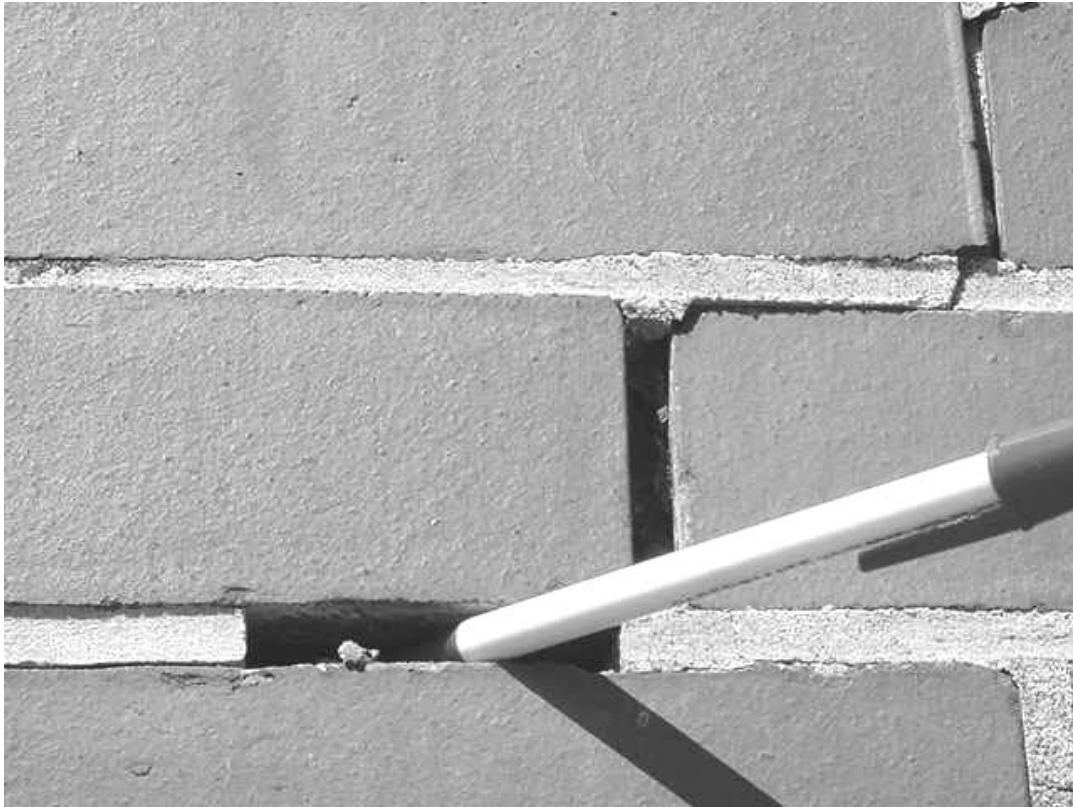
**Picture 7**

BEHA staff observed building envelope breaches, which could also provide a source of water penetration. Exterior walls of the building have problems with water intrusion. Water intrusion through exterior brick was evident by the presence of efflorescence (e.g. mineral deposits) and water-damaged building materials. As moisture penetrates and works its way through mortar around brick, it leaves behind these characteristic mineral deposits. A perimeter inspection of the exterior of the building also revealed missing, damaged and crumbling mortar around brickwork (see Pictures 7 & 8). These conditions are breaches of the building envelope and provide a means for water entry into the building.

**Missing/Damaged Mortar around Bricks, Pen Inserted to Show Depth**

12. Consider having the building re-pointed to prevent further water damage and to preserve structural integrity of the building.
13. Inspect roof for proper drainage; consider consulting a building engineer about possible options to eliminate water pooling on roof.

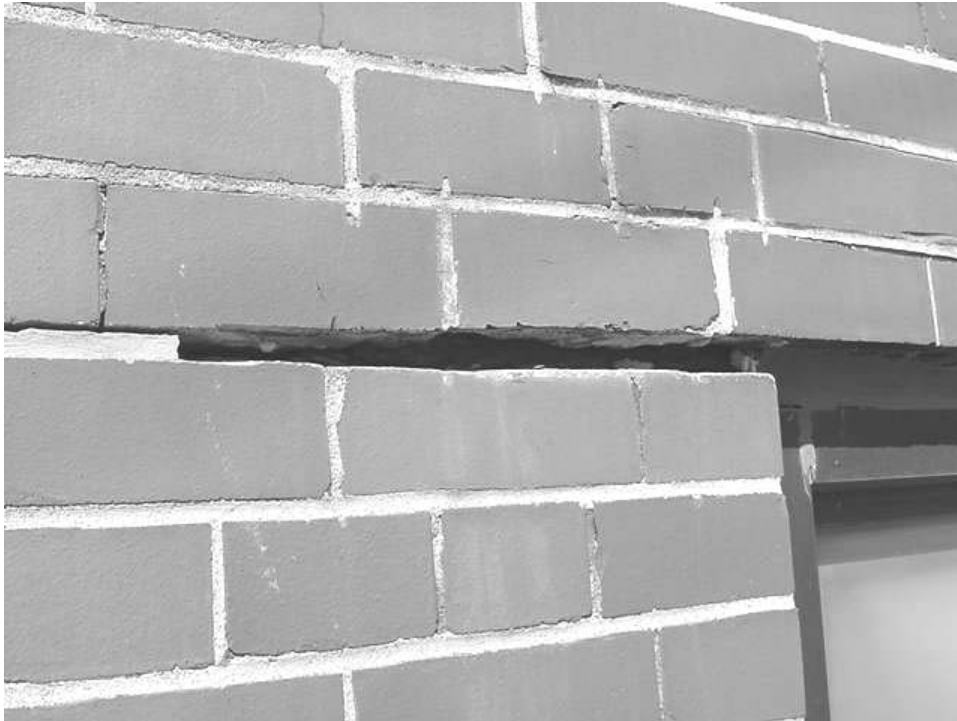
**Picture 8**

**Missing/Damaged Mortar around Bricks Exposing Metal of Window Frame**

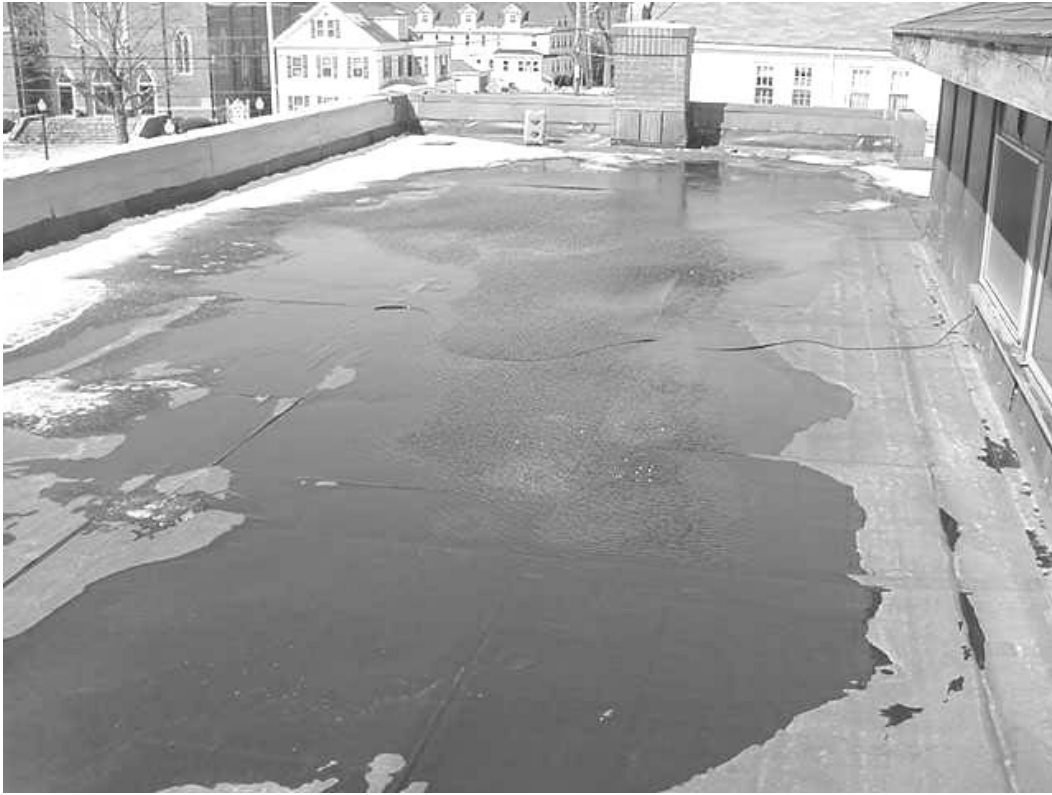
**Picture 9**

Pooling water was observed in a number of areas on the roof (see Picture 9). The freezing and thawing of water during winter months can lead to roof leaks and subsequent water penetration into the interior of the building. Pooling water can also become stagnant, which can lead to mold and bacterial growth, which can be introduced into the building by rooftop fresh air intakes. In addition, stagnant pools of water can serve as a breeding ground for mosquitoes.

**Pooling Water on Roof - Note Lack of Roof Drains**

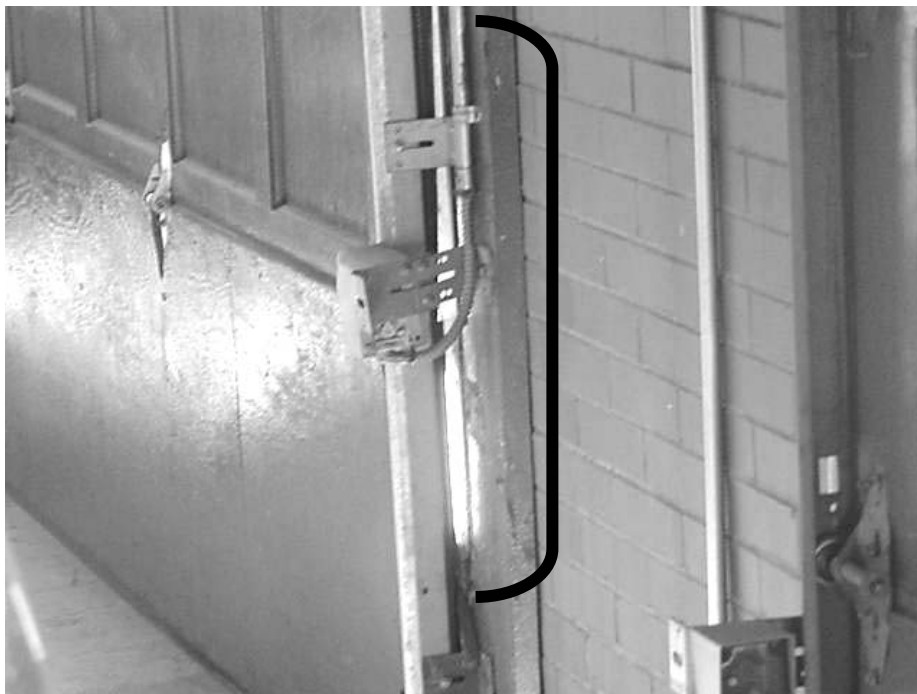
**Picture 10**

- Engine bay exterior doors had significant spaces around them from which drafts could be felt and light could be seen (see Picture 10). Drafts can pressurize the engine bays, forcing pollutants into occupied areas through any available pathways.
- Light was seen penetrating around the access hatch that separates the fire pole on the second floor from the engine bay, indicating a potential pathway (see Pictures 11 & 12).

**Spaces around Engine Bay Doors**

2. Keep all doors and windows accessing engine bays closed at all times.
3. Consider replacing engine bay doors or have them repaired to eliminate spaces between doors and frames. Ensure tightness by monitoring for light penetration and drafts around doorframes.

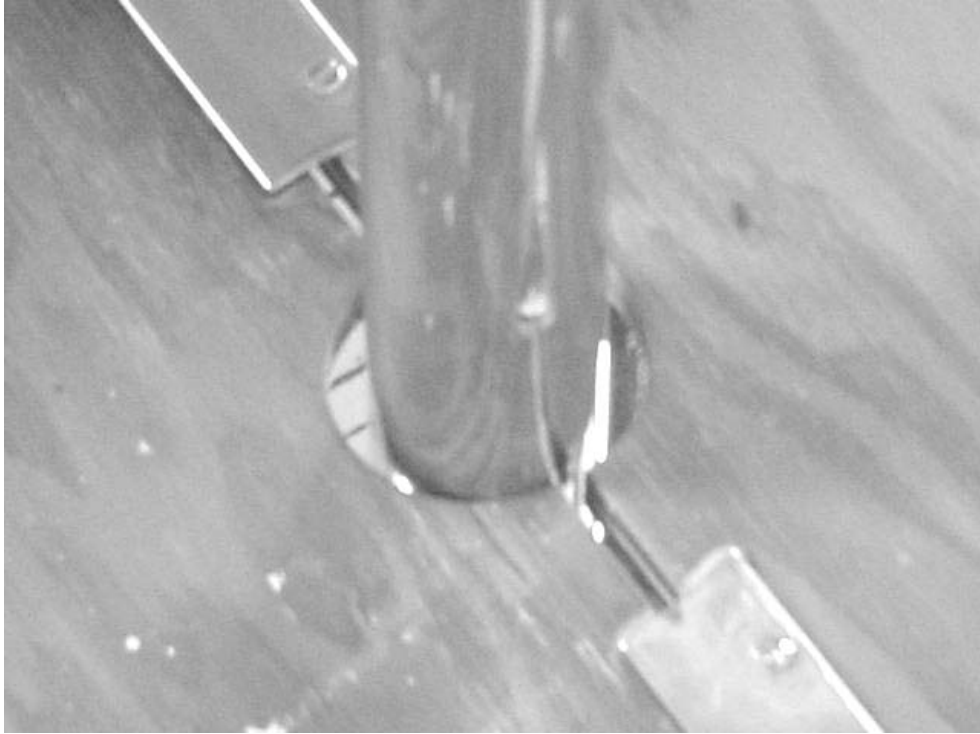
**Picture 11**

**Spaces around Fire Pole Access Hatch (view from top)**

4. Consider replacing fire pole access hatch with an alternate design that forms an airtight seal to prevent pollutant pathways into occupied areas. If not feasible, seal hatch on all sides with foam tape, and/or weather-stripping. Ensure tightness by monitoring for light penetration and drafts.

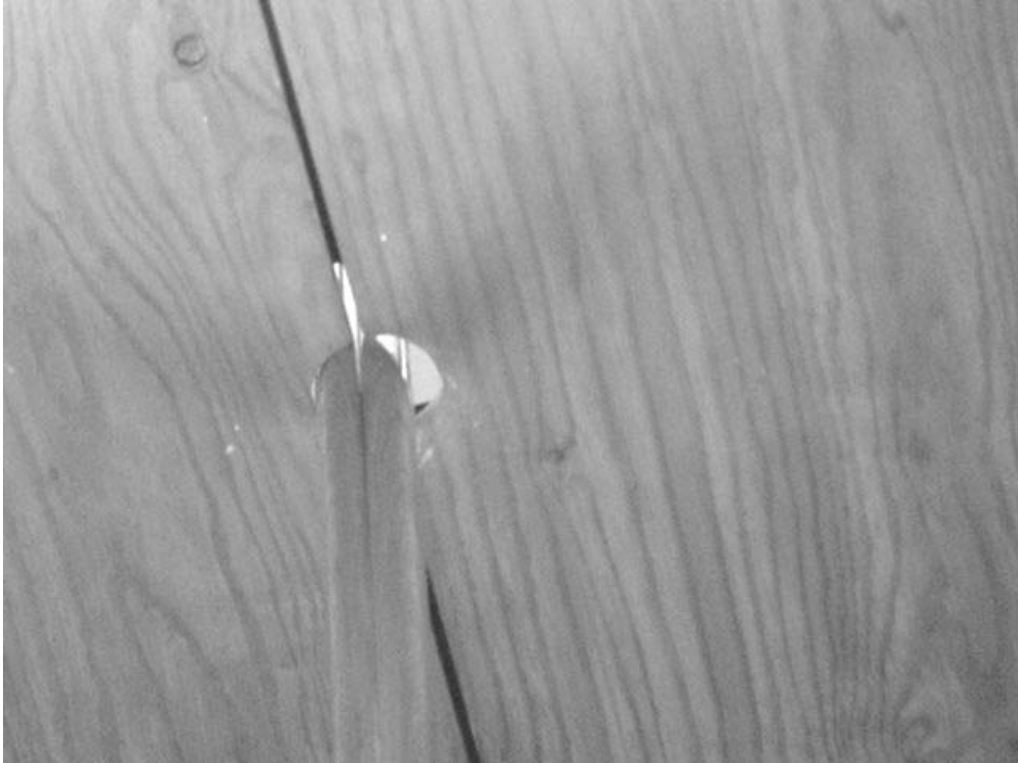
**Picture 12**

**Spaces around Fire Pole Access Hatch (view from underneath/engine bay)**
